**State of Louisiana
Coastal Protection and Restoration Authority**

2017 Annual Inspection Report

**Pass Chaland to Grand Bayou Pass
Barrier Shoreline Restoration**

State Project Number BA-35
Priority Project List 11

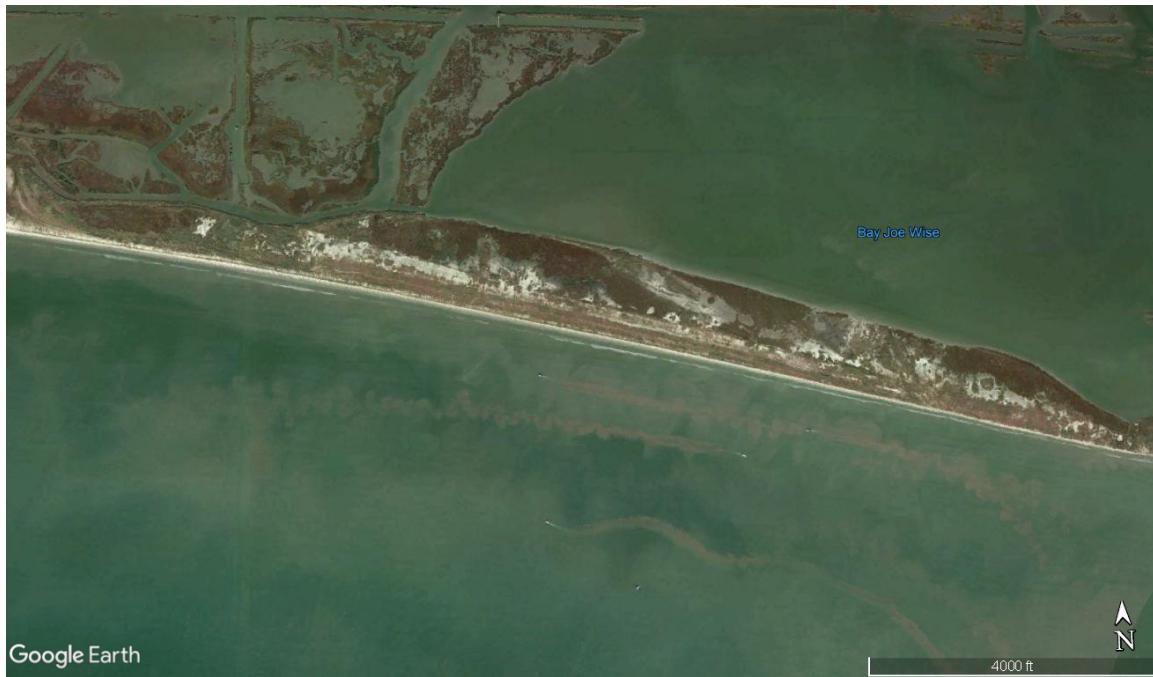
Photo #1 – Full Project Area.

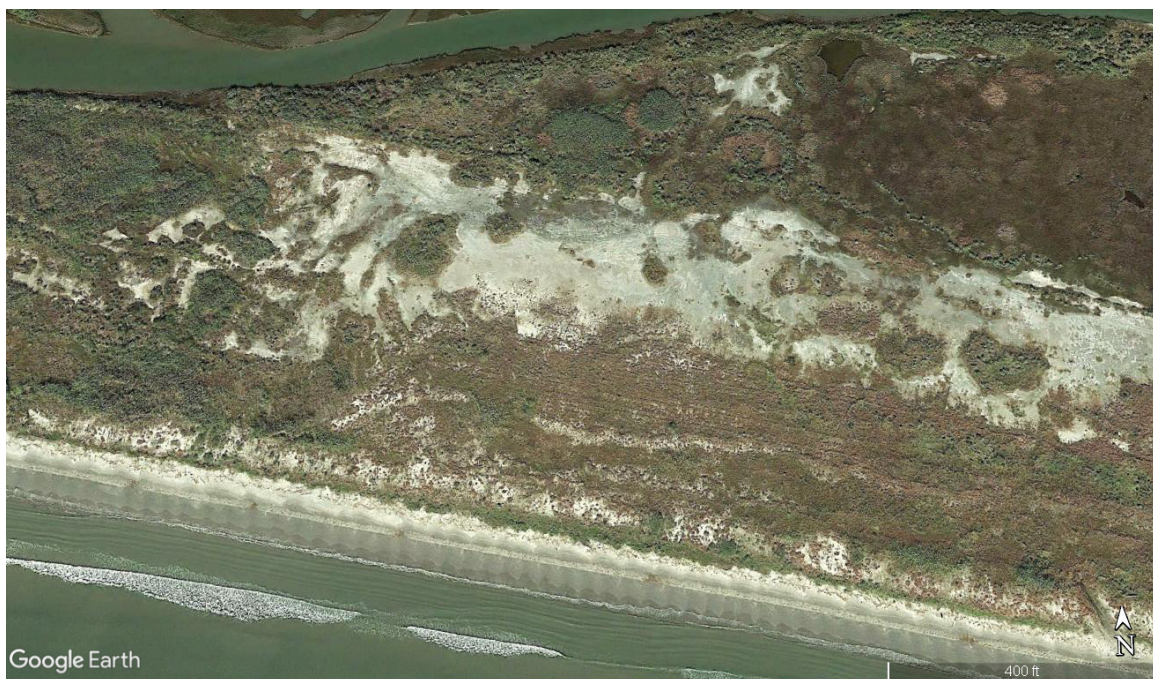
The project has vegetated nicely over the years.

Photo #2 – West End Beach and Dune Vegetation.

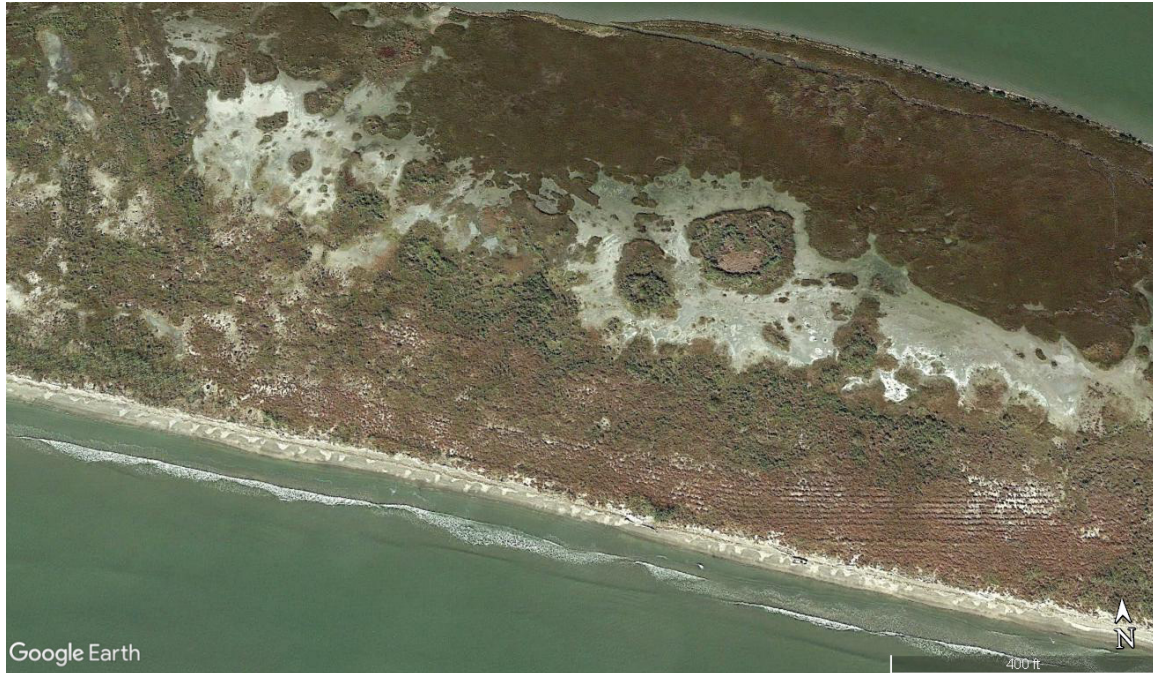
Photo #3 – East End Beach and Dune Vegetation.

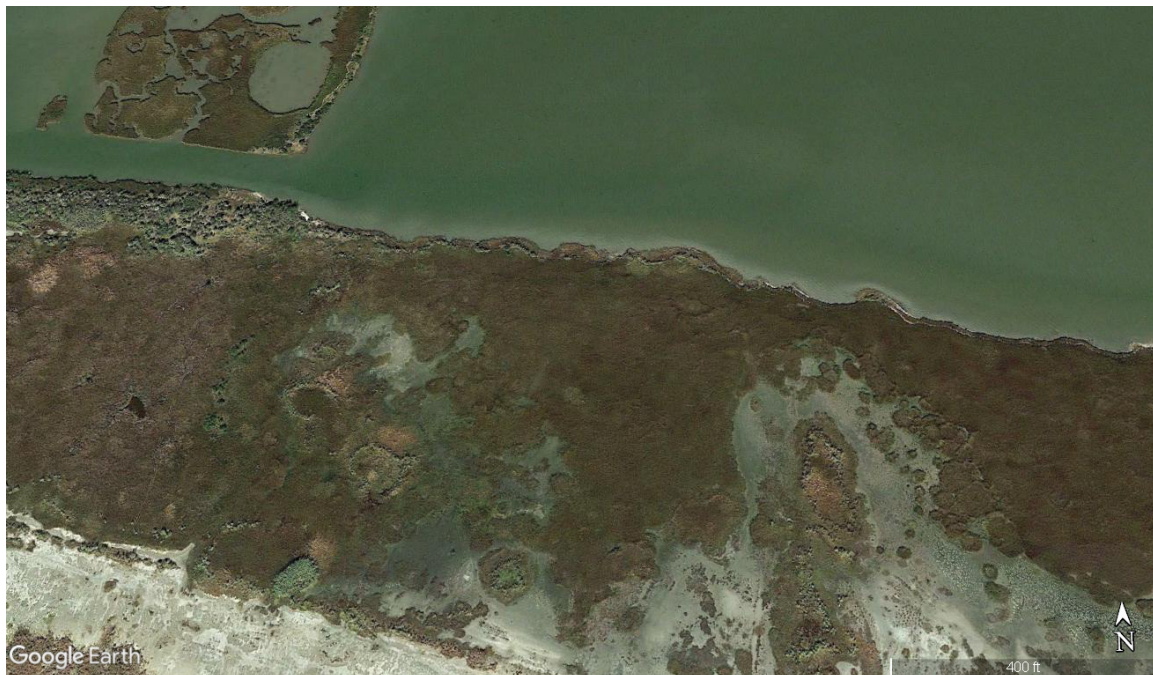
It appears this structure has almost completely degraded in the bay but remains intact along the small stretch outside of the bay. Some erosion appears to have encroached on the marsh platform along a few stretches.

Photo #4 – West End Marsh and Containment Dike Degradation.

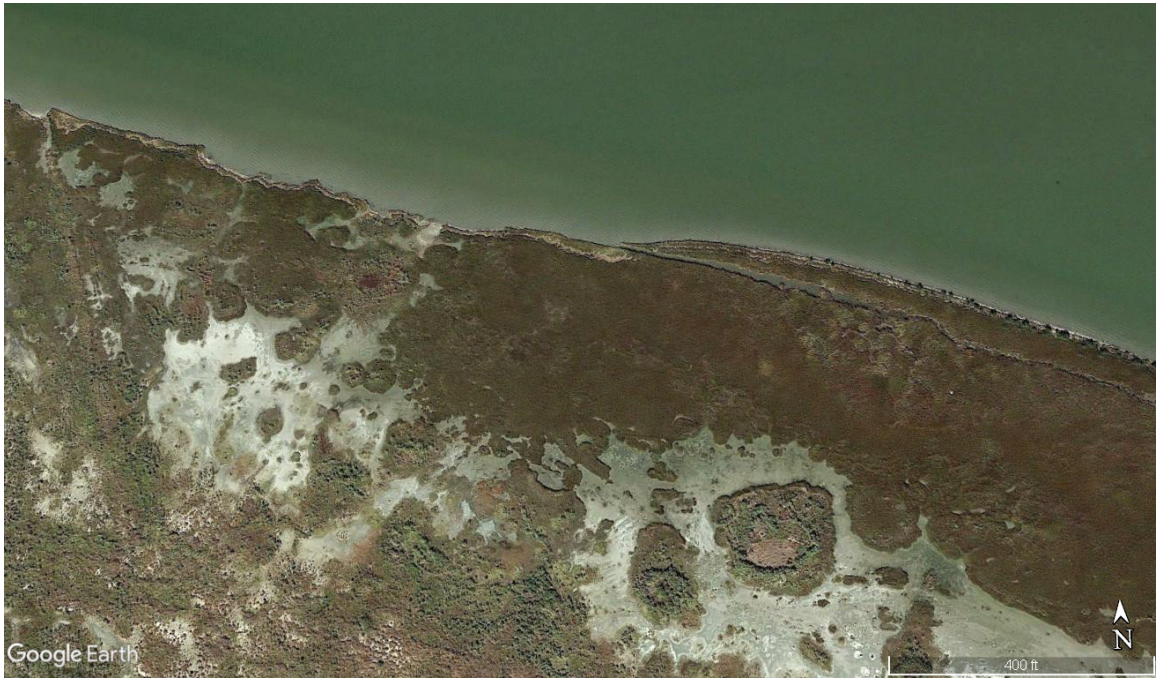
Photo #5 – East End Marsh and Containment Dike Degradation.
